**Flood Control Project Maintenance  
Levee Inspections****LMA District Cover Sheet****Spring 2015 Levee Inspection Results****Sutter Maintenance Yard Maintenance Area 0003**

**Levee Inspection Report By Mile - Spring 2015**

**Sutter Maintenance Yard Maintenance Area 0003**

Waterway	Bank	Unit Miles	Inspection Start/End	Inspector
Unit No. 01 Feather River	Right	5.11	04/17/2015 04/17/2015	Michael Pitta

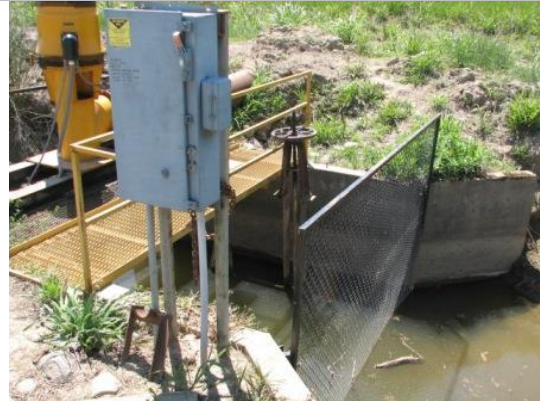
Photo 1 of 1 : SP\_2015\_MA0003\_195\_5\_20150401\_00001.jpg

LM Start	0.80	Rating **	M	Issue No.	5
LM End	0.80	Issue Type +	Ma	Location *	LS
Category	Interior Drainage & Piping Systems			GPS Latitude/Longitude	
				Start	End
Item	Sluice / Slide Gates			38.903291 °	38.903291 °
				-121.605747 °	-121.605747 °
DWR ID	DWR_MA0003_01_s _ 2012_5				
Action/Comments					
Inspector Comments: This pipe leaked during the high water event of 2010/2011.

Levee mile 0.80, this photo is looking at the landside toe, one of these pipes leaked during the high water event of 2010/2011. A flap gate prevents flow from the waterward side to the landward side of the levee.

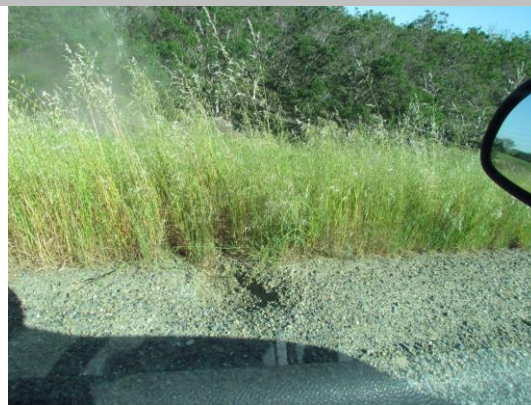
Photo 1 of 1 : SP\_2015\_MA0003\_195\_13\_20150421\_00012.jpg

LM Start	1.51	Rating **	M	Issue No.	13
LM End	1.51	Issue Type +	Ma	Location *	CR
Category	Earthen Levee			GPS Latitude/Longitude	
				Start	End
Item	Crown Surface / Depressions / Rutting			38.904680 °	38.904680 °
				-121.594229 °	-121.594229 °
DWR ID	DWR MA0003 01 s 2015 13

Photo of a depression in the crown, taken looking at the landside.

Action/Comments					
Repair depressions or ruts in the crown or slope.

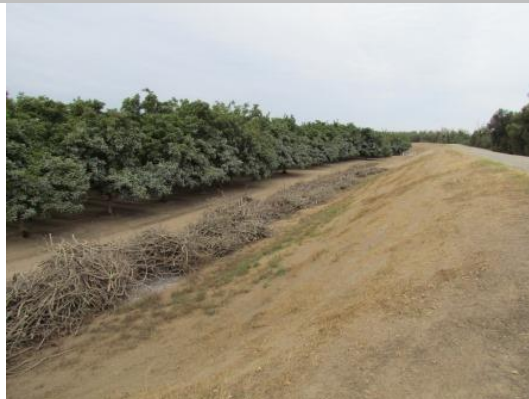
Photo 1 of 1 : SP\_2015\_MA0003\_195\_141\_20150401\_00010.jpg

LM Start	2.19	Rating **	U	Issue No.	141
LM End	2.19	Issue Type +	En	Location *	LS
Category	Earthen Levee			GPS Latitude/Longitude	
				Start	End
Item	Encroachments			38.912027 °	38.912027 °
				-121.585941 °	-121.585941 °
DWR ID	DWR MA0003 01 f 2014 141

Action/Comments					
Prunings

This photo was taken from the crown facing north looking down the landward levee slope at pruning piles located at the levee toe that need to be removed. Fall 2014.

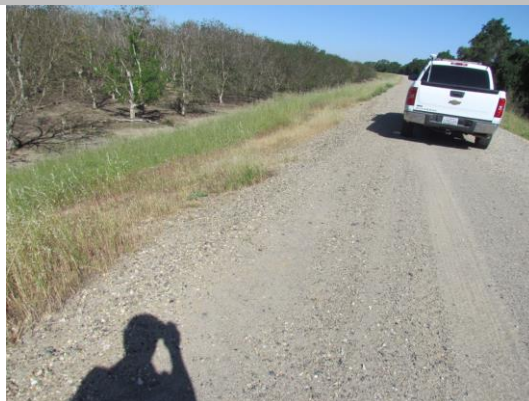
Photo 1 of 1 : SP\_2015\_MA0003\_195\_20\_20150421\_00013.jpg

LM Start	3.20	Rating **	M	Issue No.	20
LM End	3.20	Issue Type +	Ma	Location *	LS
Category	Earthen Levee			GPS Latitude/Longitude	
				Start	End
Item	Slope Stability			38.925909 °	38.925909 °
				-121.585401 °	-121.585401 °
DWR ID	DWR_MA0003_01_s _ 2015_20				
Action/Comments					
Repair slope instability.

Photo of slope on the landside facing upstream, areas with little vegetation appear to have eroded leaving the crown smaller.

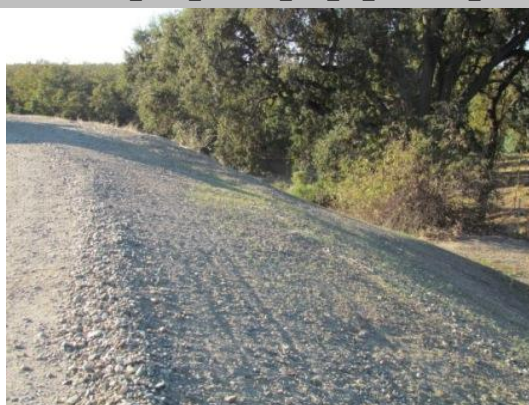
Photo 1 of 1 : SP\_2015\_MA0003\_195\_19\_20150401\_00007.jpg

LM Start	3.59	Rating **	M	Issue No.	19
LM End	3.59	Issue Type +	Ma	Location *	LS
Category	Earthen Levee			GPS Latitude/Longitude	
				Start	End
Item	Vegetation			38.930063 °	38.930063 °
				-121.590211 °	-121.590211 °
DWR ID	DWR_MA0003_01_f _ 2013_19				
Action/Comments					
Elderberries are blocking visibility and flood fight capability. Inspector Comments: Elderberries on the landward levee toe.

This photo was taken from the levee crown facing south looking down the landward levee slope at a group of Elderberries. Fall 2013.

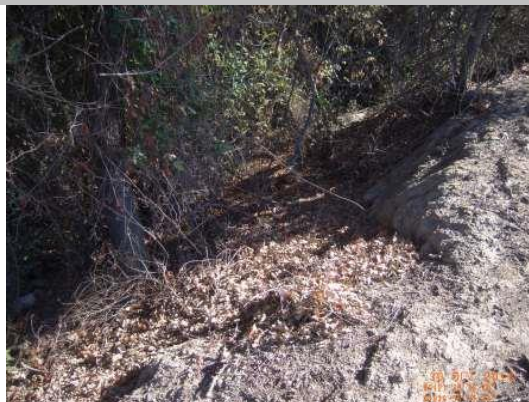
Photo 1 of 2 : SP\_2015\_MA0003\_195\_10\_20150401\_00002.jpg

LM Start	4.15	Rating **	M	Issue No.	10
LM End	4.18	Issue Type +	Ma	Location *	WS
Category	Supplemental			GPS Latitude/Longitude	
				Start	End
Item	USACE Erosion Survey			38.937454 °	38.937937 °
				-121.588544 °	-121.588471 °
DWR ID	DWR_MA0003_01_f _ 2014_10				
Action/Comments					
Inspector Comments: 2013: Minor toe scour causing gradual erosion of bank slope. Site is within ecological reserve. [2013 Site ID: FHR_12-3_R]

USACE 2013 Photo #1

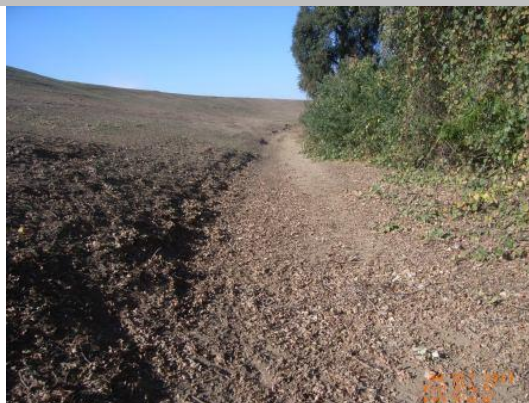
Photo 1 of 2 : SP\_2015\_MA0003\_195\_11\_20150401\_00004.jpg

LM Start	4.71	Rating **	M	Issue No.	11
LM End	4.76	Issue Type +	Ma	Location *	WS
Category	Supplemental			GPS Latitude/Longitude	
				Start	End
Item	USACE Erosion Survey			38.945190 °	38.945967 °
				-121.586073 °	-121.586328 °
DWR ID	DWR_MA0003_01_f_2014_11				
Action/Comments					
Inspector Comments: 2013: Minor toe scour causing gradual erosion into the bank slope [2013 Site ID: FHR_12-8_R]

USACE 2013 Photo #1

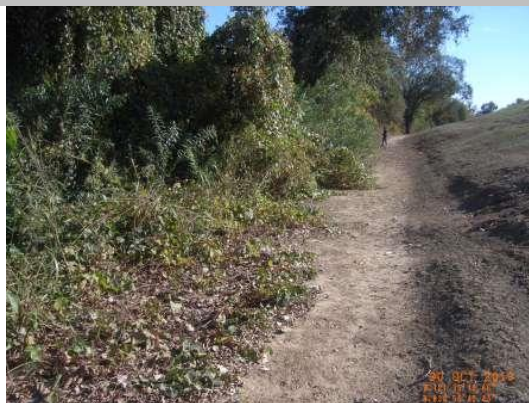
Photo 2 of 2 : SP\_2015\_MA0003\_195\_11\_20150401\_00005.jpg

USACE 2013 Photo #2
